NACA RM E52K13

PRELIMINARY INVESTIGATION IN J33 TURBOJET ENGINE OF SEVERAL
ROOT DESIGNS FOR CERAMAL TURBINE BLADES

By George C. Deutsch, Andre J. Meyer, Jr.
and William C. Morgan

Lewis Flight Propulsion Laboratory
Cleveland, Ohio

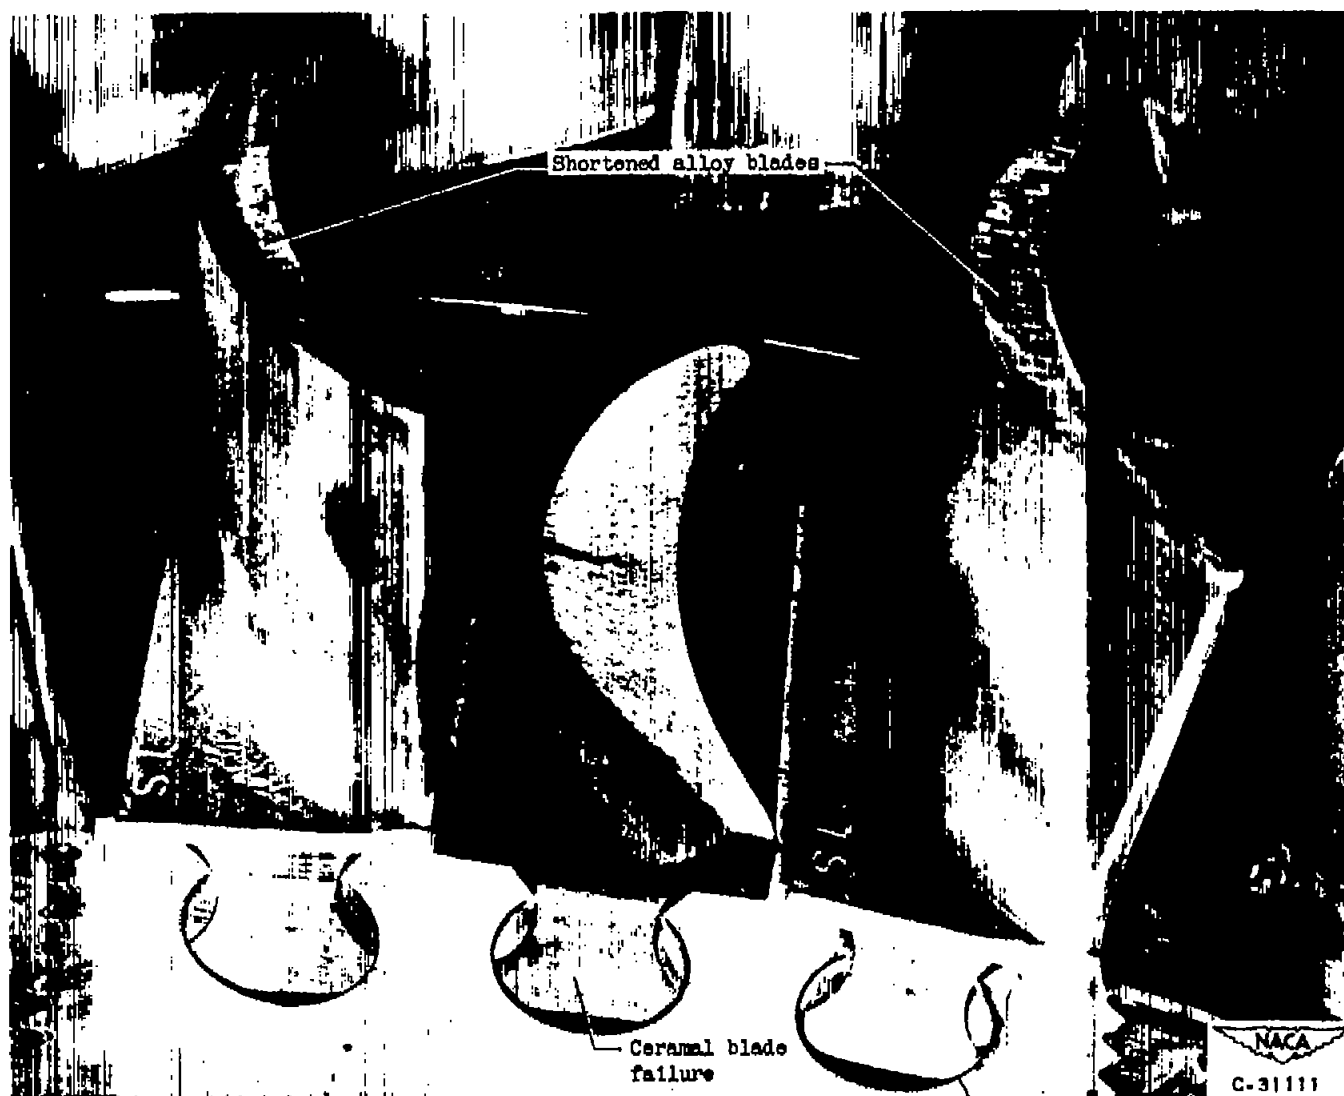
Interlock blade runs. - Runs 5 and 6 each used a single ceramal blade with two adjacent shortened alloy blades and three shortened alloy blades at diametrically opposite positions in the wheel. The gaps left in the wheels by these shortened blades apparently caused a major disturbance in the normal vibration characteristics of the engine because in each case unusually severe vibrations occurred which resulted in severe damage to the struts supporting the "bullet" in the tailcone. After run 5 these struts had a large number of cracks which were repaired by welding. After run 6 the damage was even more extensive and the struts collapsed. While it appears probable that this severe vibration caused the blade airfoil failures, the alloy blades in the remainder of the wheel experienced no apparent damage under the same conditions. A ceramal failure in these runs is shown in figure 5.

Figure 5. - Failure of ceramal blade having interlock root due to severe engine vibration.

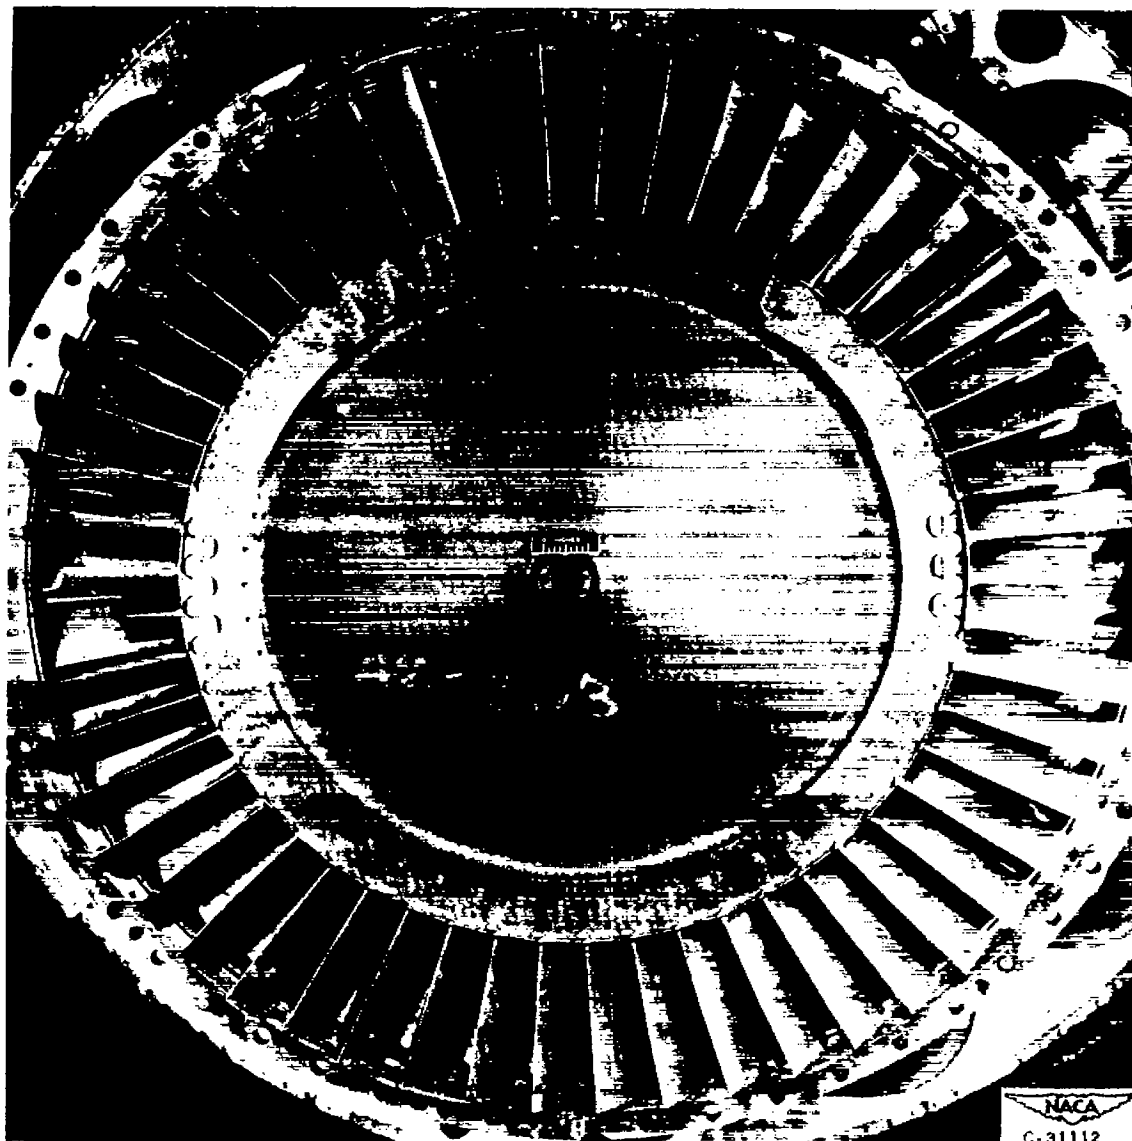
Run 7 utilized six ceramal blades and was an attempt to correct the vibration conditions of the two previous runs. The appearance of the failure (fig. 6) indicates that the first blade to fail was the one in which half the airfoil is missing. The remainder of the failures appear to have resulted from impact by fragments from the first failure. Microscopic examination of the blade that is presumed to have failed first did not reveal any defect in this blade.

During disassembly of the engine after runs 5, 6, and 7, it was noted that several of the combustion-chamber-liner positioning pins had also failed. If these failed prior to the blade failure and then passed through the turbine, their impact with the blades could account for the comparatively low time of operation of these runs.

Figure 6. - Failure of ceramal blades having interlock roots after 1 hour and 10 minutes of operation. Failure occurred at 11,370 rpm.

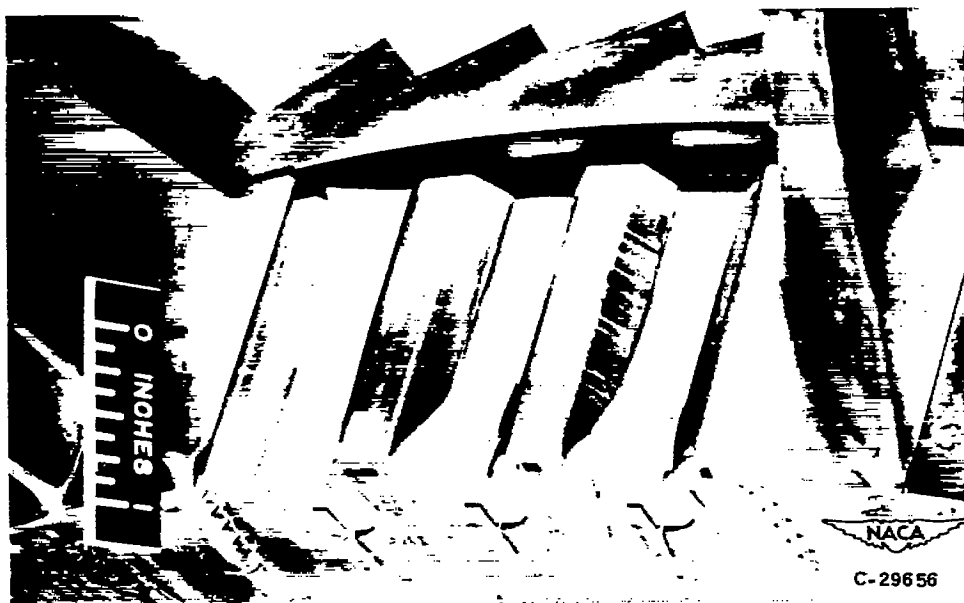
After 68 hours and 23 minutes at rated speed, failure occurred. Three of the blades on one side of the wheel failed in the root (fig. 7) while the three opposing blades (fig. 8) suffered relatively little damage. No cause for the failures could be ascertained.

Figure 7. - Failure of ceramal blades having interlock roots after 68 hours and 28 minutes of operation. Failure occurred at rated speed.

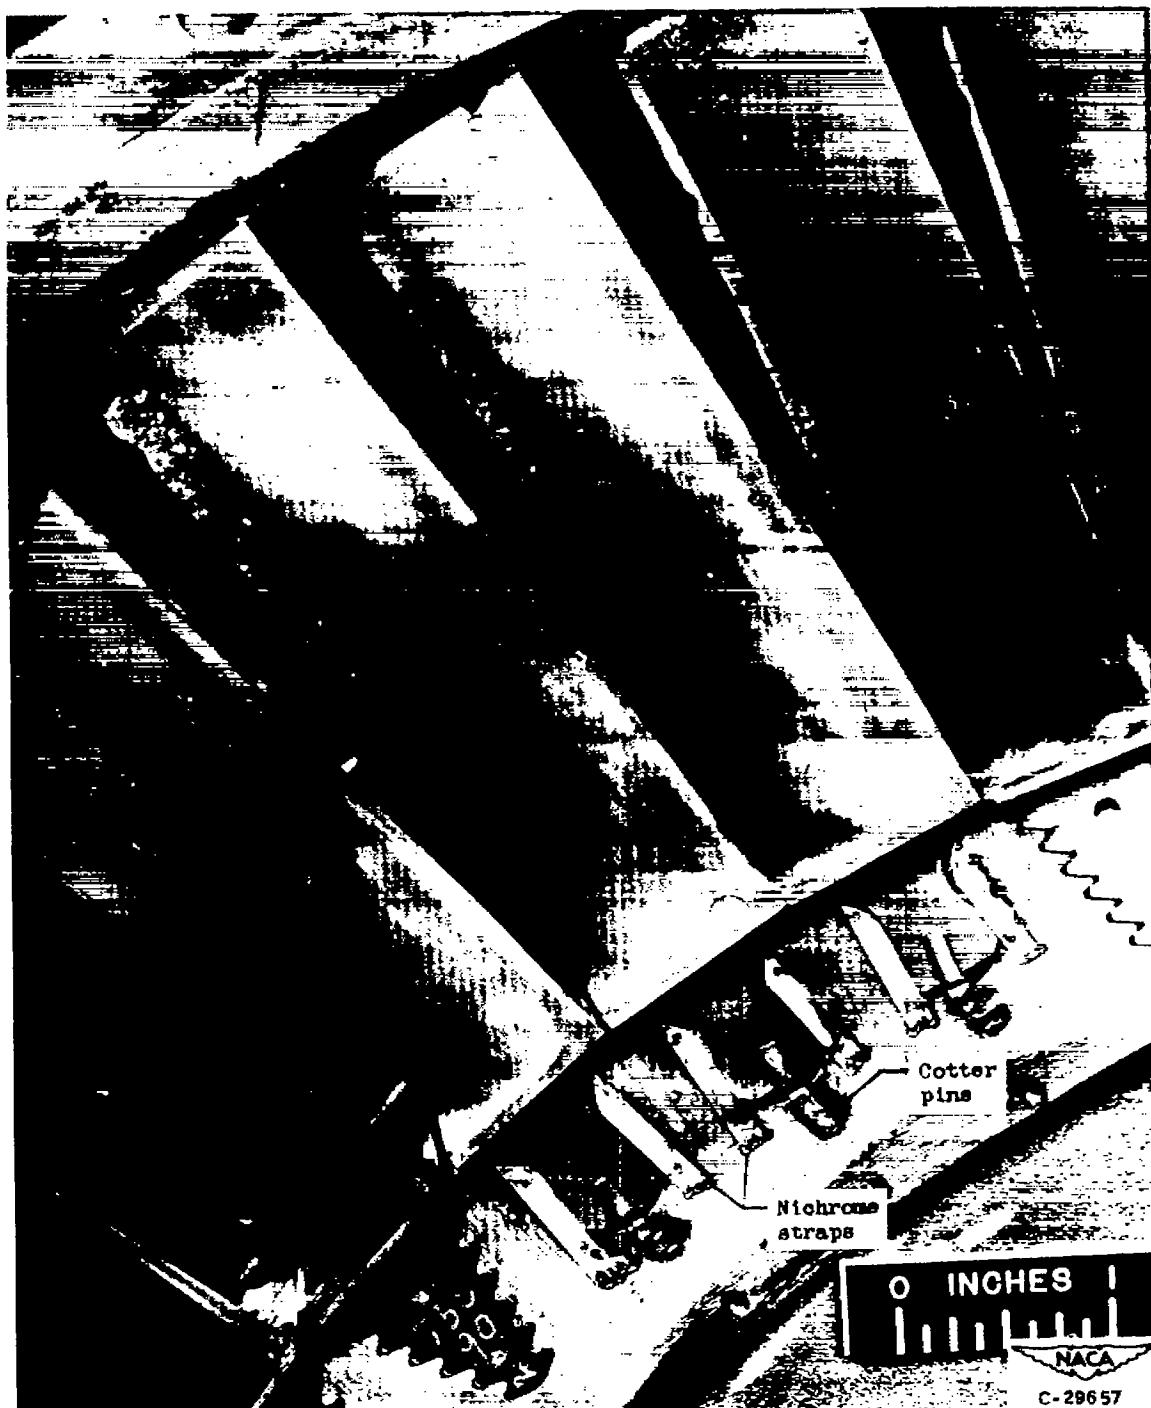
Figure 8. - Damage to ceramic turbine blades (interlock root) caused by fragments of failed ceramic turbine blade.

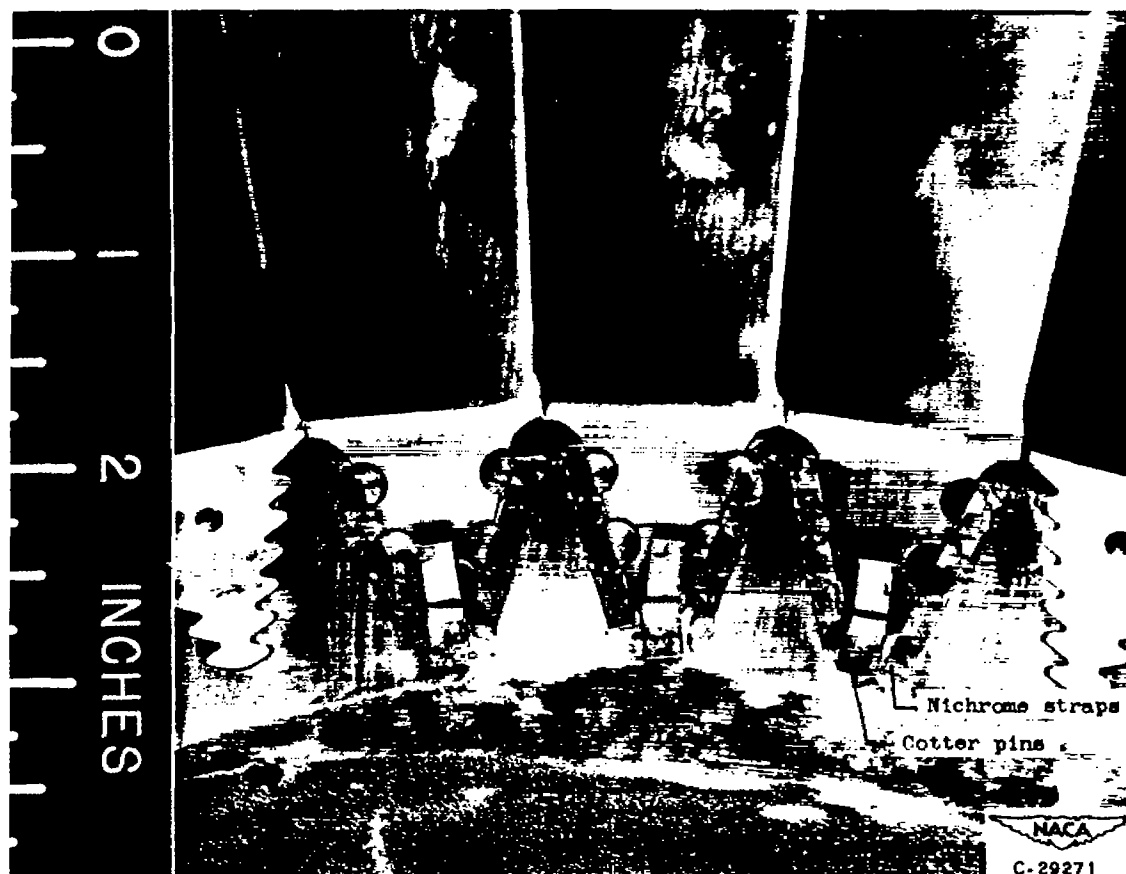
engine failed, necessitating that the engine be slowed to idle speed as rapidly as possible. After 9 hours and 42 minutes of operation (7 hr and 9 min of operation at rated conditions), the blades were all in good condition. After 19 hours and 42 minutes of operation (16 hr and 8 min at rated speed), two out of the three blades in one cluster and one out of the three blades in the other cluster were fractured across the bottom two retaining pins (fig. 10). The time these failures occurred is unknown; it appeared probable that the blade had been running in this failed condition for several hours. As the cotter pins were no longer effective in restraining the blades, a sheetmetal strap was installed across the top row of pins and operation was continued (fig. 11).

Figure 10. - Failure of ceramal blade having 4-pin root after 18 hours and 8 minutes of operation at rated speed.

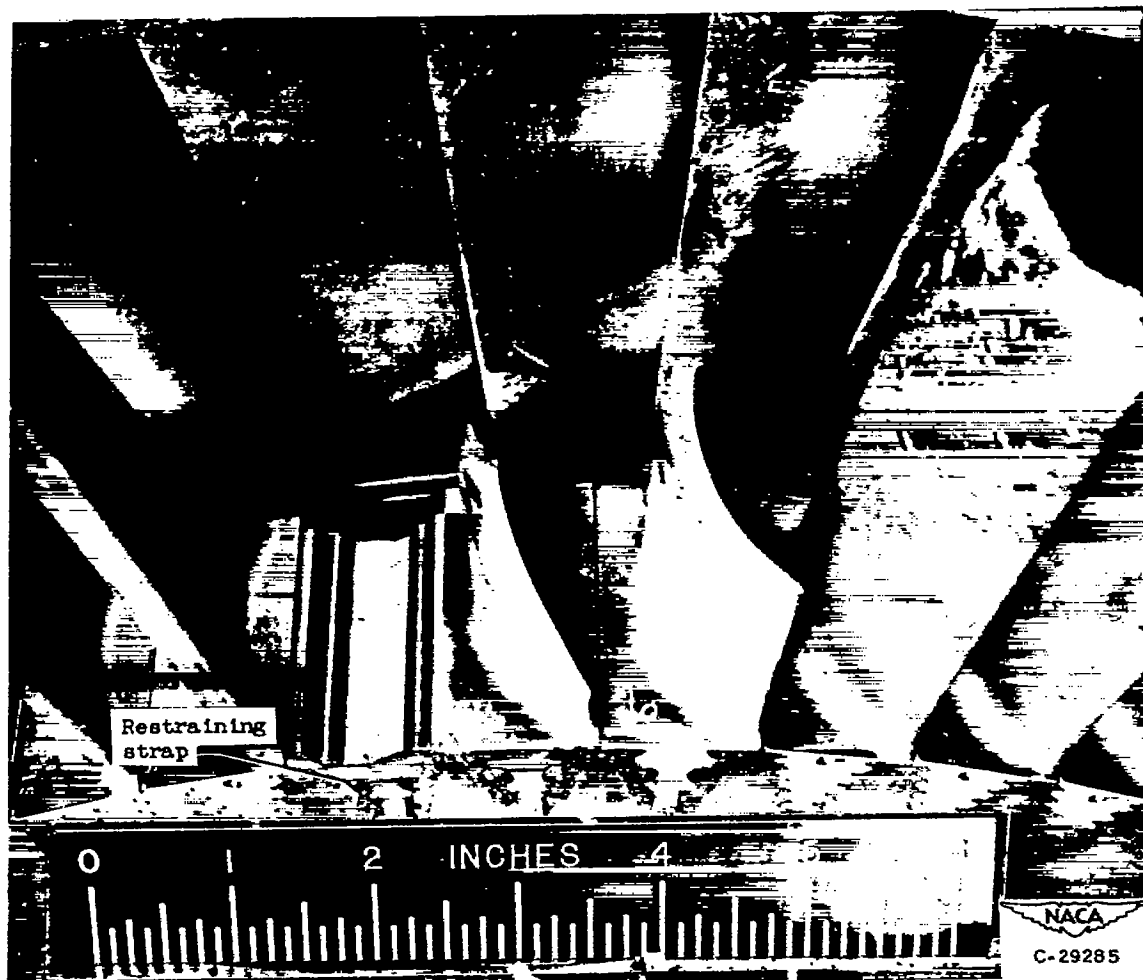
After 20 hours and 30 minutes at rated speed one blade failed across the top two pins and the fragments damaged the remaining 5 blades (fig. 8(b)). As in run 7, inspection during engine disassembly showed that several of the combustion-chamber-liner retaining pins had failed and that there had been severe damage to the aft end of the engine.

Figure 11. - Failure of ceramal blade having 4-pin root after 20 hours and 30 minutes of operation at rated speed.

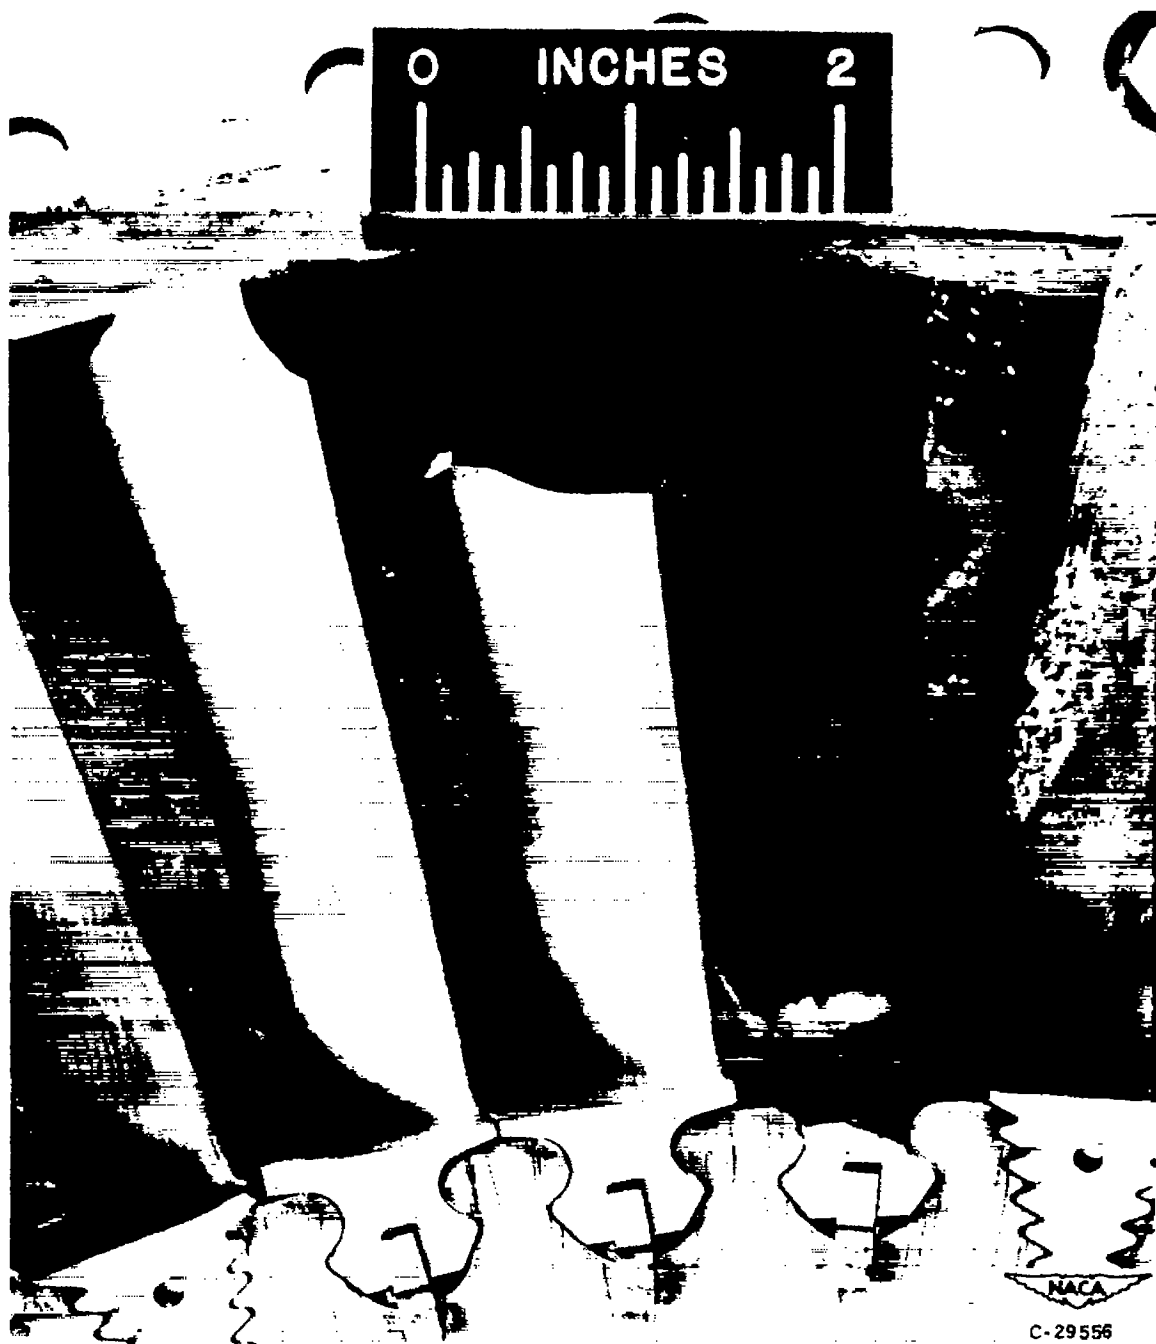
Dovetail run. - In this run mechanical failure of engine accessories necessitated three emergency shutdowns. These did not result in visible damage to the blades. After 58 hours and 28 minutes of operation at rated speed, one blade failed across the root (fig. 9) and damaged both the adjacent ceramal blades and the ceramal blades on the opposite side of the wheel, as well as several alloy blades (fig. 10). An enlarged view of this failed root is shown in figure 11. From the impression of the screen on the blade, it is evident that the screen was plastically deformed during the test. A sharp line of contact between the screen and the root can be noted in the figure. The cracks appear to follow this line. The stress concentration which caused the failure may have existed in this area.

Figure 12. - Failure of ceramic turbine blades having dovetail roots after 5 hours and 28 minutes at rated speed.

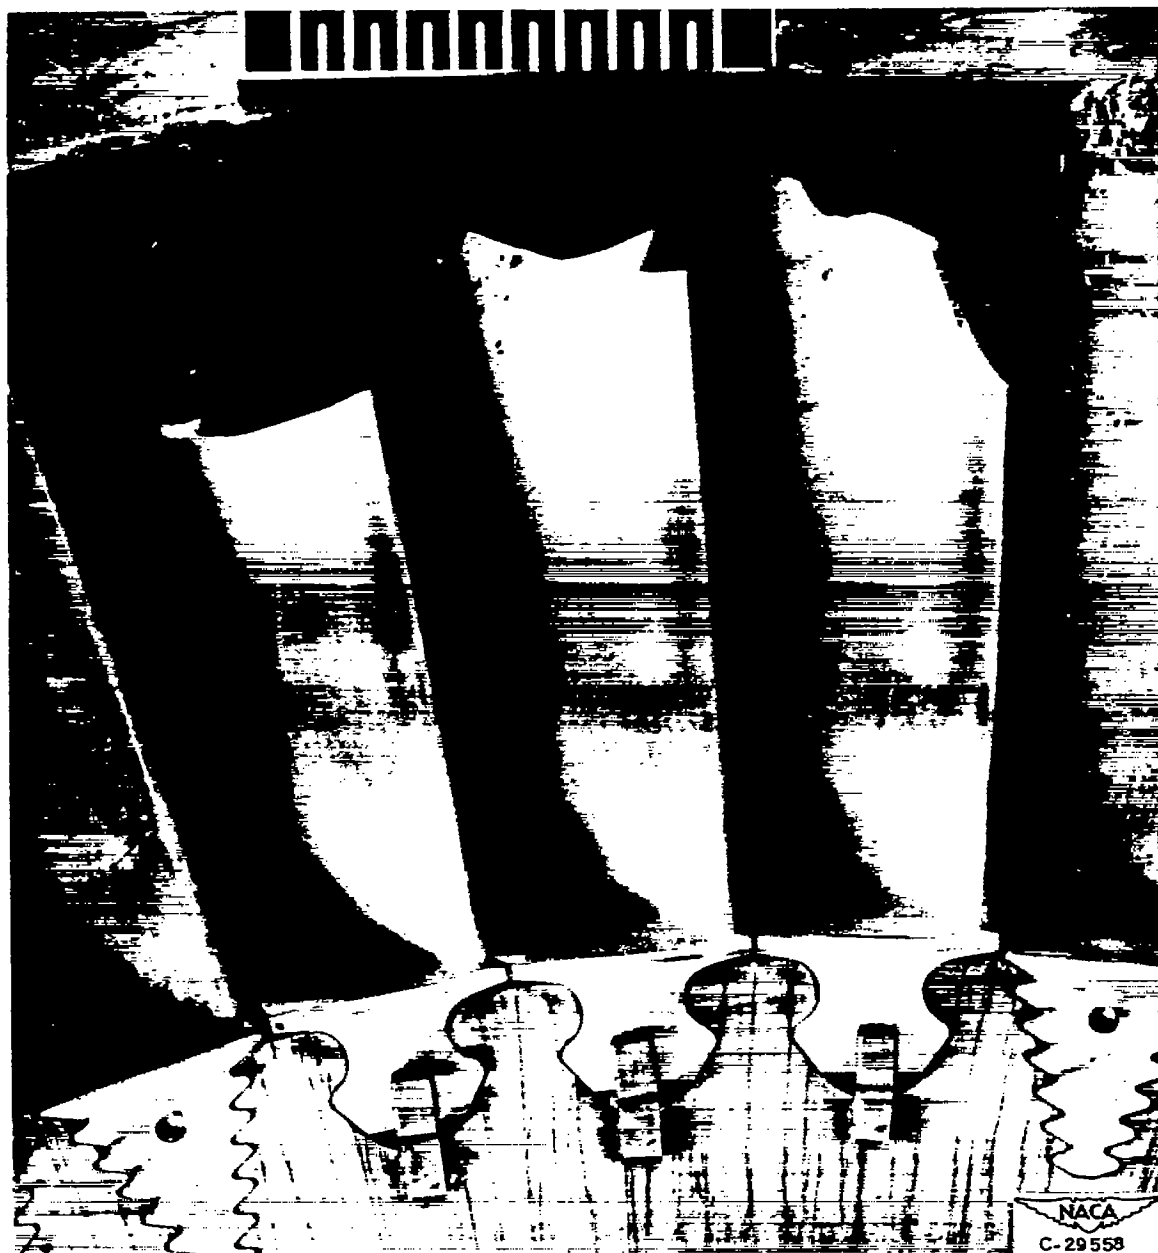
Figure 13. - Damage to ceramal turbine blades (dovetail root) caused by fragments of failed ceramal turbine blades.
